# Well Head Treatment Project

## Water Well 13

This PowerPoint was originally presented to City Council in 2003.

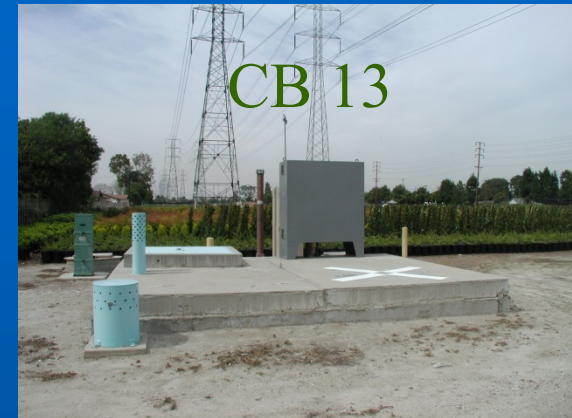
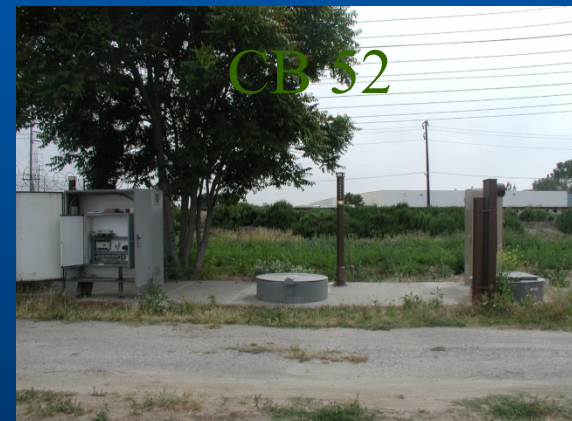
# CB 13 and 52

- **CB 13-Located at the end of San Marcus Street.**
- **CB 52 at the north end of Orange Avenue**
- **Connection to MWD**
- **Meets 30-40% of production need**

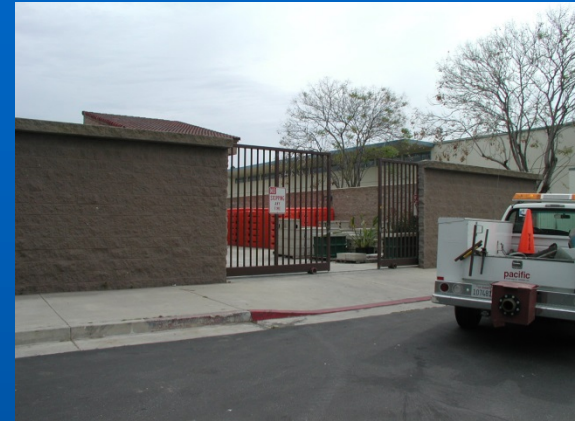
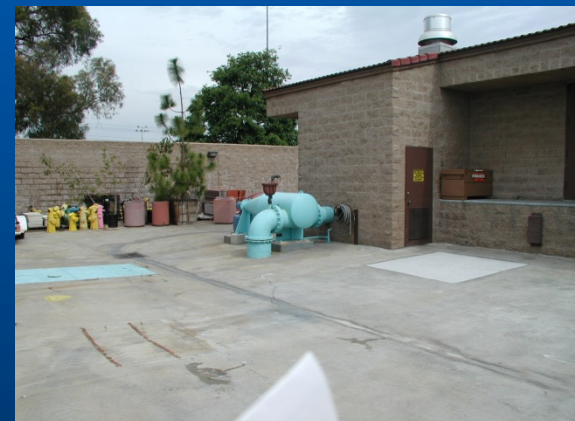
# Well 14

- **Located:**
  - Behind Alondra School
- **Built in 1984**
- **Produces approx. 1/3 of the City's total water demand**

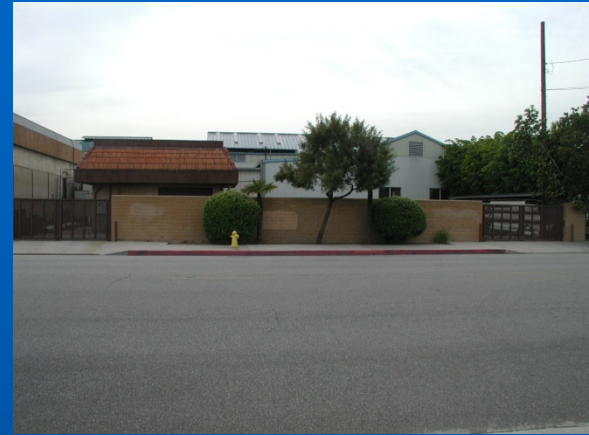
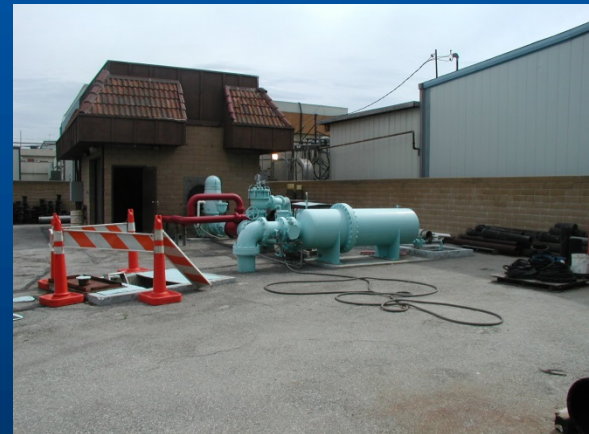
# Well 13

- **Located:**
  - 15123 Vermont Avenue
- **Built in 1978**
- **Produces approx. 1/4 City production need.**

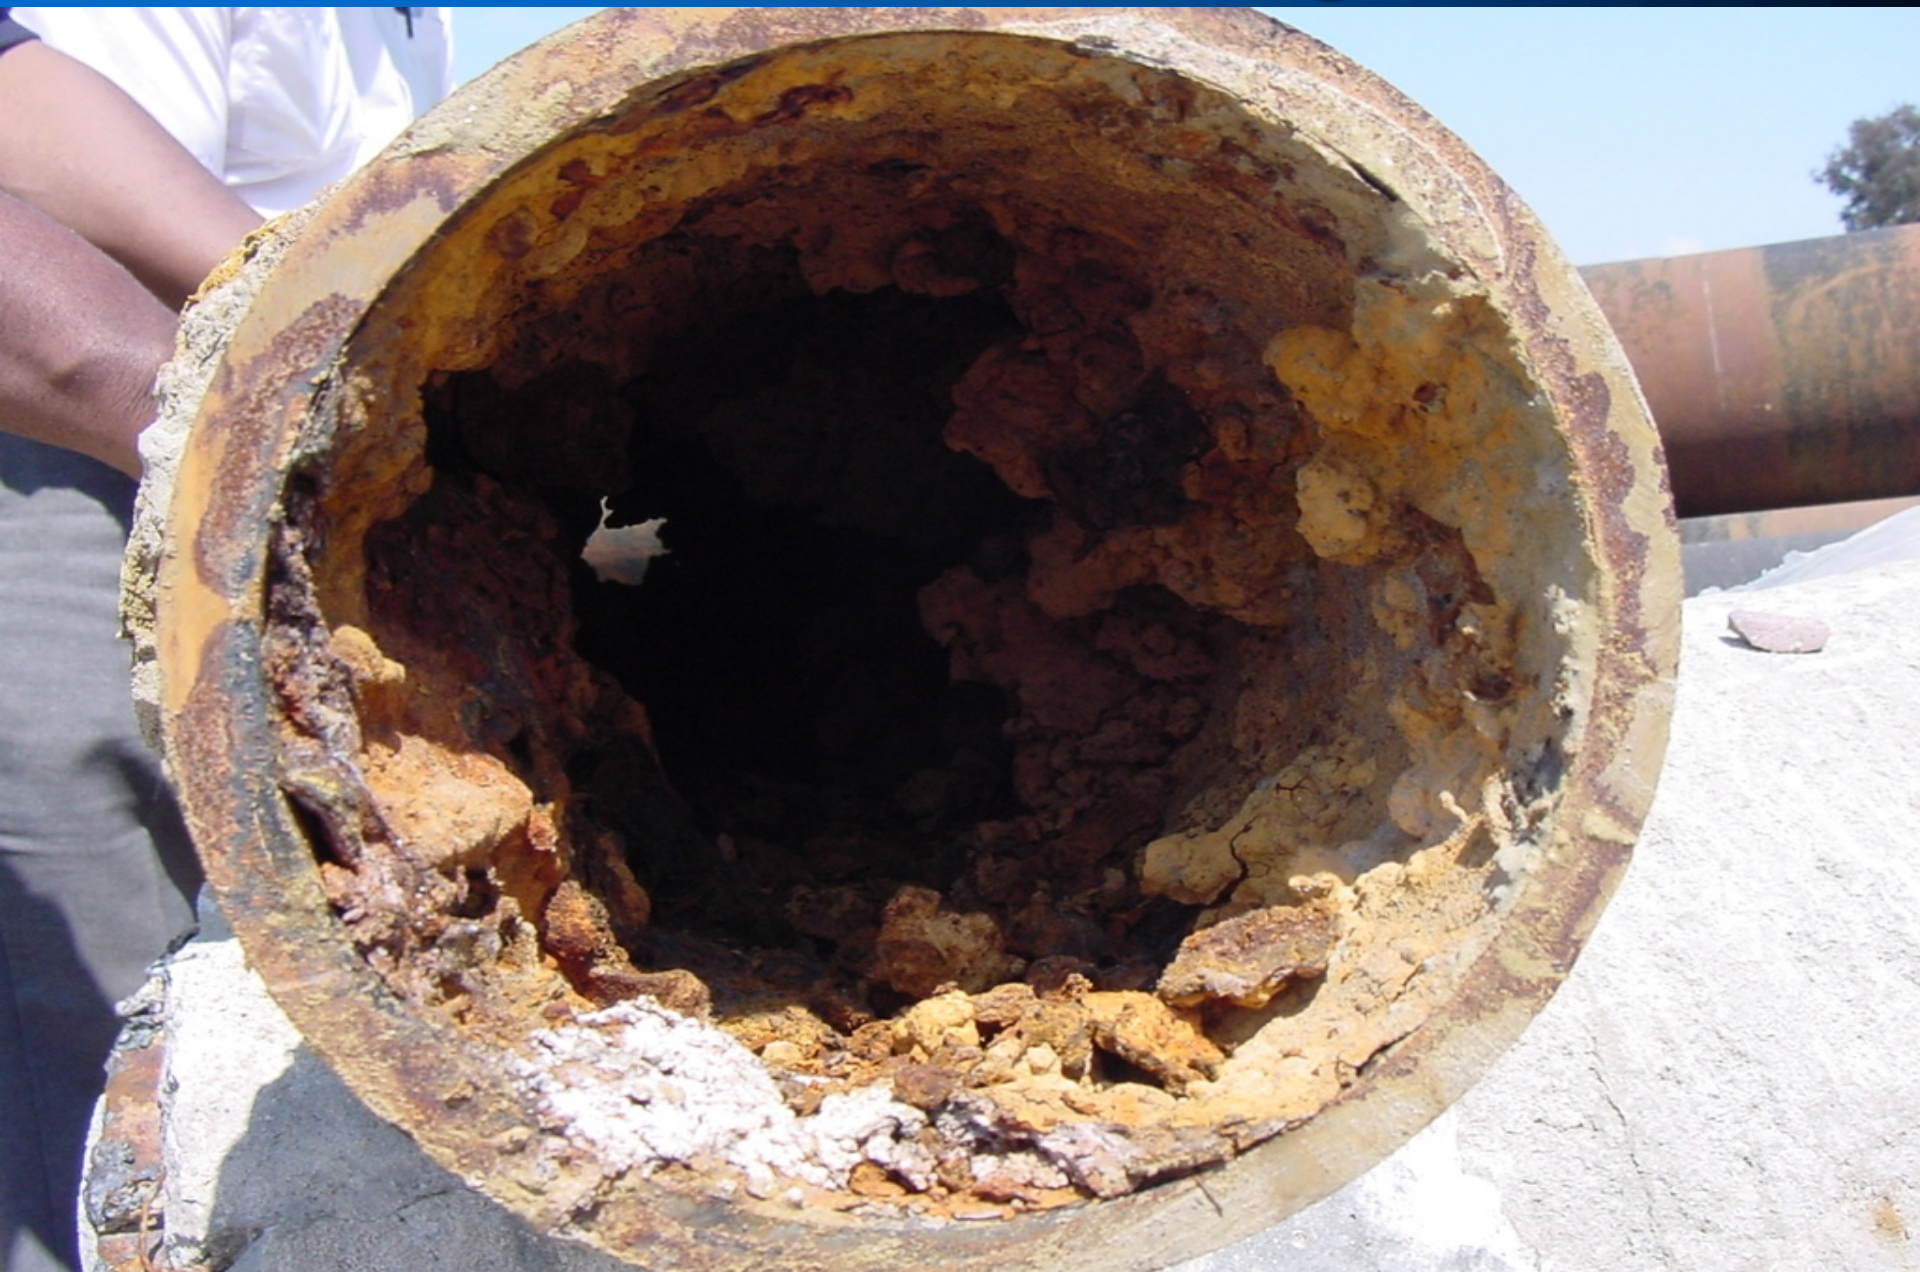
# Cast Iron Main and Manganese

- Manganese is naturally found in drinking water.
- Manganese has no adverse health affect.
- Manganese can cause discolored water and damage water mains.

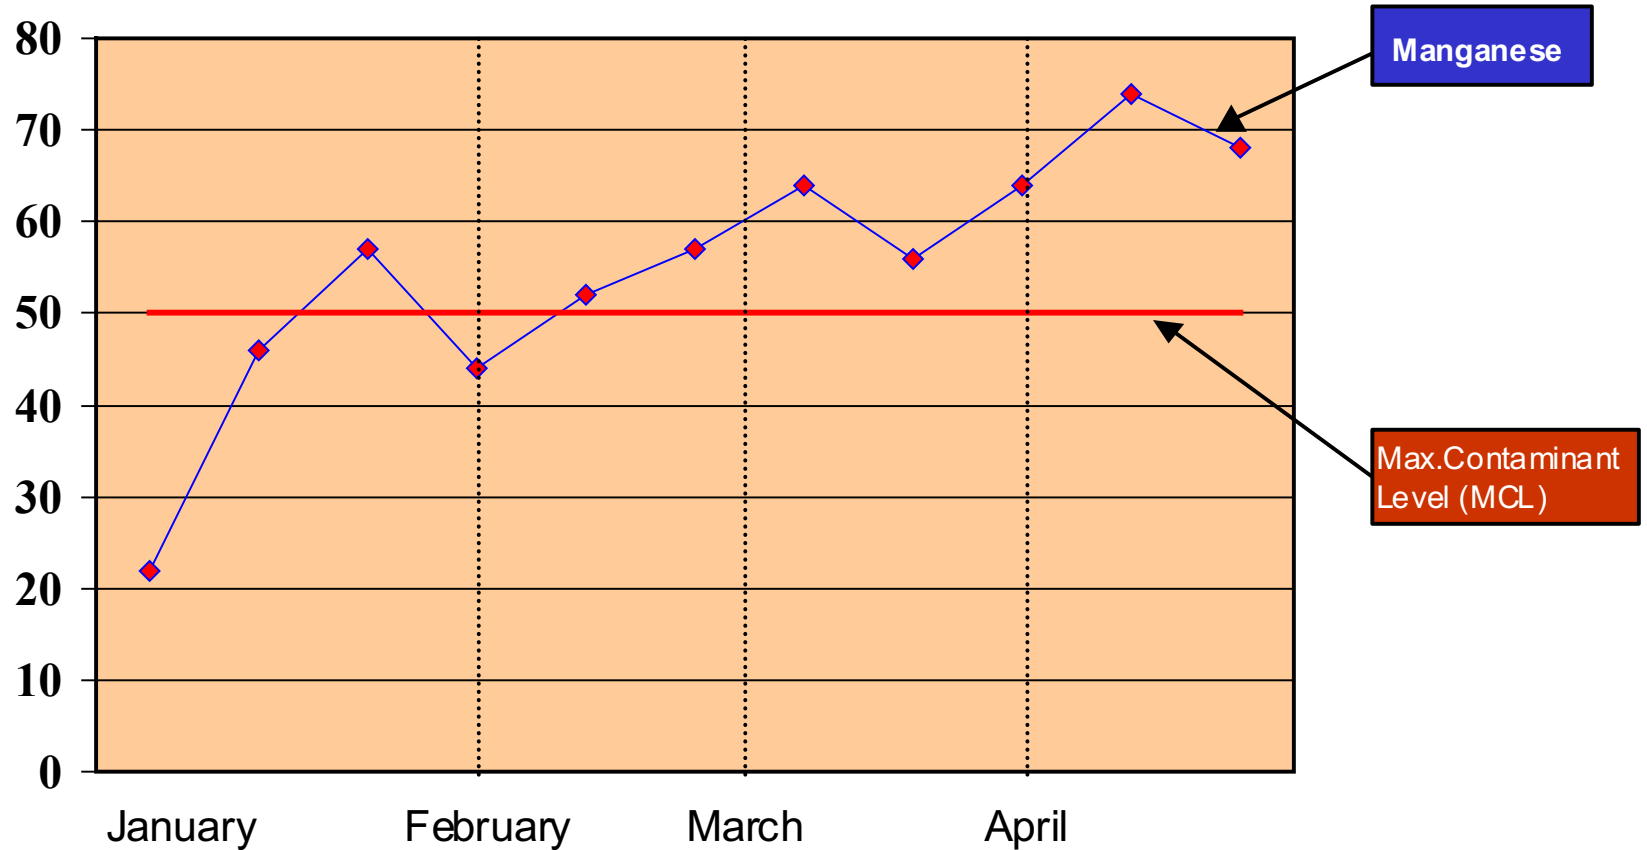
# Manganese Sample History-Well 13

January to April, 2003

- Manganese MCL:
  - 50 parts per billion
- Well 13 Manganese level:
  - Exceeding 50 parts per billion
- 1994-1997-Manganese level:
  - averaged 80 parts per billion

- **1998-City issued Compliance Order by Department of Health Services (DHS) to reduce Manganese.**
- **City agrees to twice monthly monitoring.**
- **August, 2002-City ends monitoring.**
  - **Manganese level drops just below MCL.**
- **January, 2003-Manganese levels begin to rise again.**

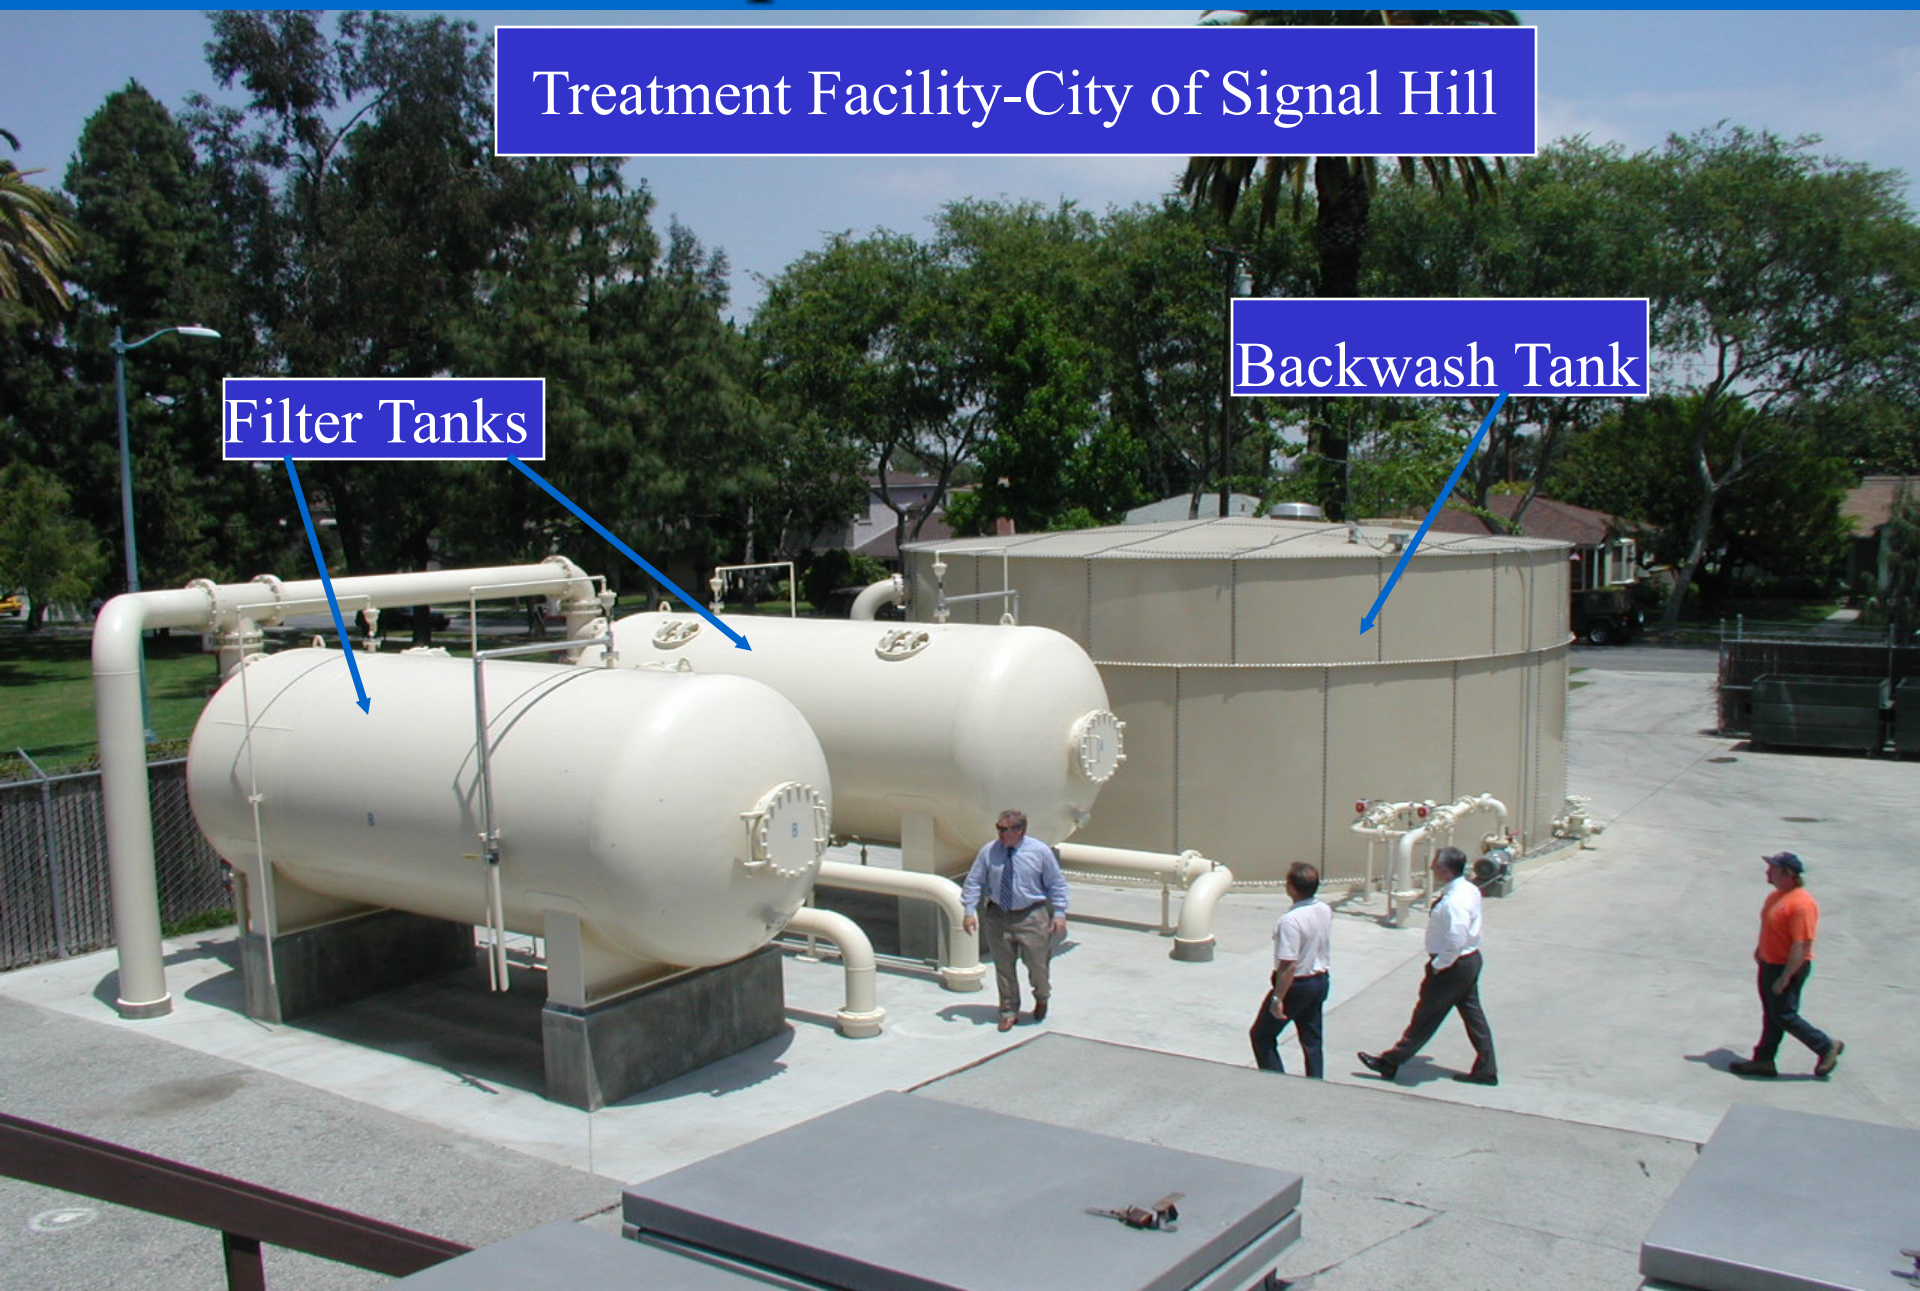
Treatment Facility-City of Signal Hill

Filter Tanks

Backwash Tank
