NOTICE OF VIOLATION: THE NATIONAL POLLUTANT DISCHARGE ELIMINATION SYSTEM (NPDES) GENERAL PERMIT FOR STORMWATER DISCHARGES ASSOCIATED WITH INDUSTRIAL ACTIVITY (ORDER NO. 2017-0057-DWQ; CAS000001) – AEROCRAFT HEAT TREATING CO., INC. WDID 4 19I000098

State of California – Environmental Protection Agency
California Regional Water Quality Control Board – Los Angeles Region
INDUSTRIAL STORM WATER INSPECTION REPORT (ORDER NO. 2014-0057-DWQ)

Aerocraft Heat Treating Co., Inc. WDID 4 19I000098
January 10, 2017, Inspection Photographs

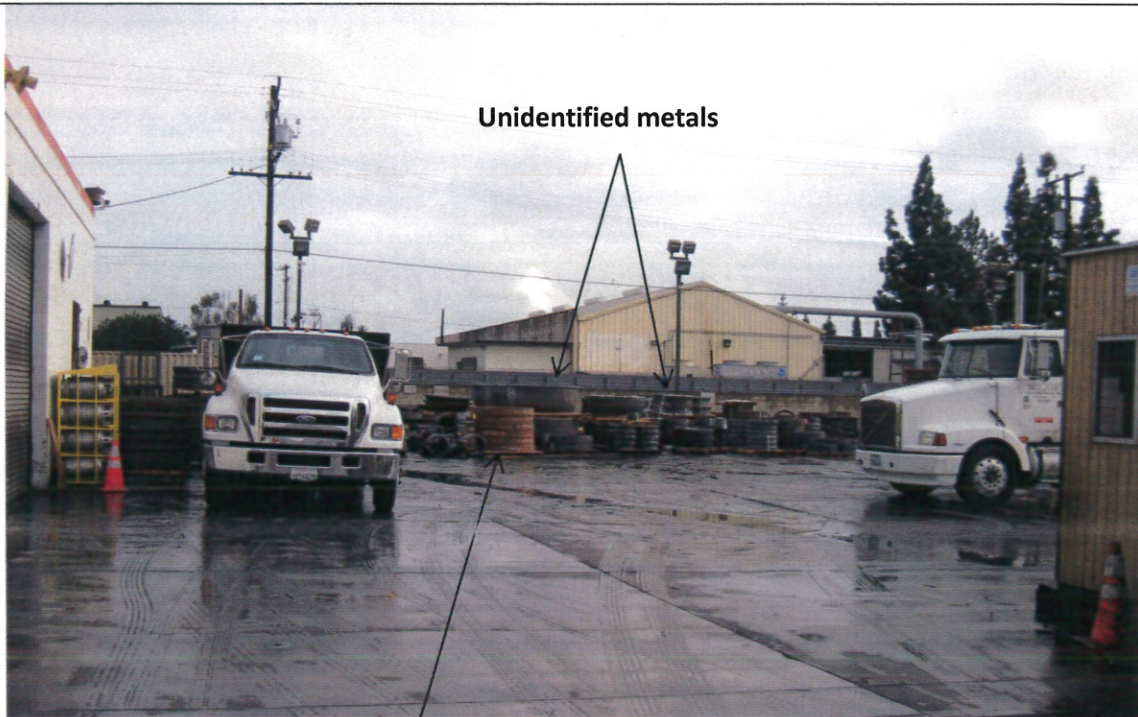
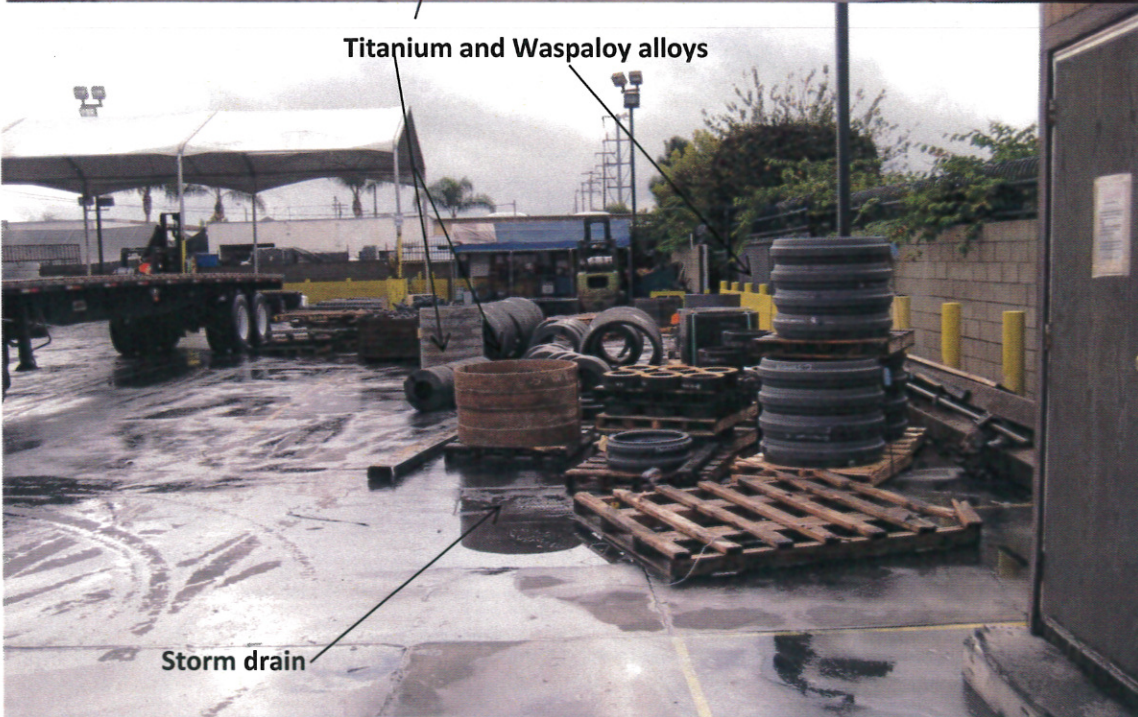
Photographs 1 and 2 –The photographs show rusty titanium, and Waspaloy (titanium and chromium alloy) alloys among other metals stored at the shipping and receiving yard outdoor's area without overhead coverage. At the time of the inspection, other metals were not identified. The alloys and metals were located next to a storm drain inlet without BMPs in place.

- Rusty metal, scrap metal parts, various types of alloys, and titanium parts, among other unidentified metals were stored outdoors without BMPs in place. At the time of the inspection, all metal stored outdoors was in direct contact with storm water runoff and discharging offsite (Photographs attached). This is a violation of General Permit Section X.H.

1. Immediately revise the facility's site map to show all points of storm water discharge and collect storm water samples from the areas as required. Submit a pdf copy of the site map via SMARTS, and amend the facility's SWPPP accordingly.
2. Immediately cover and raise rusty metal exposed to precipitation on site above ground.

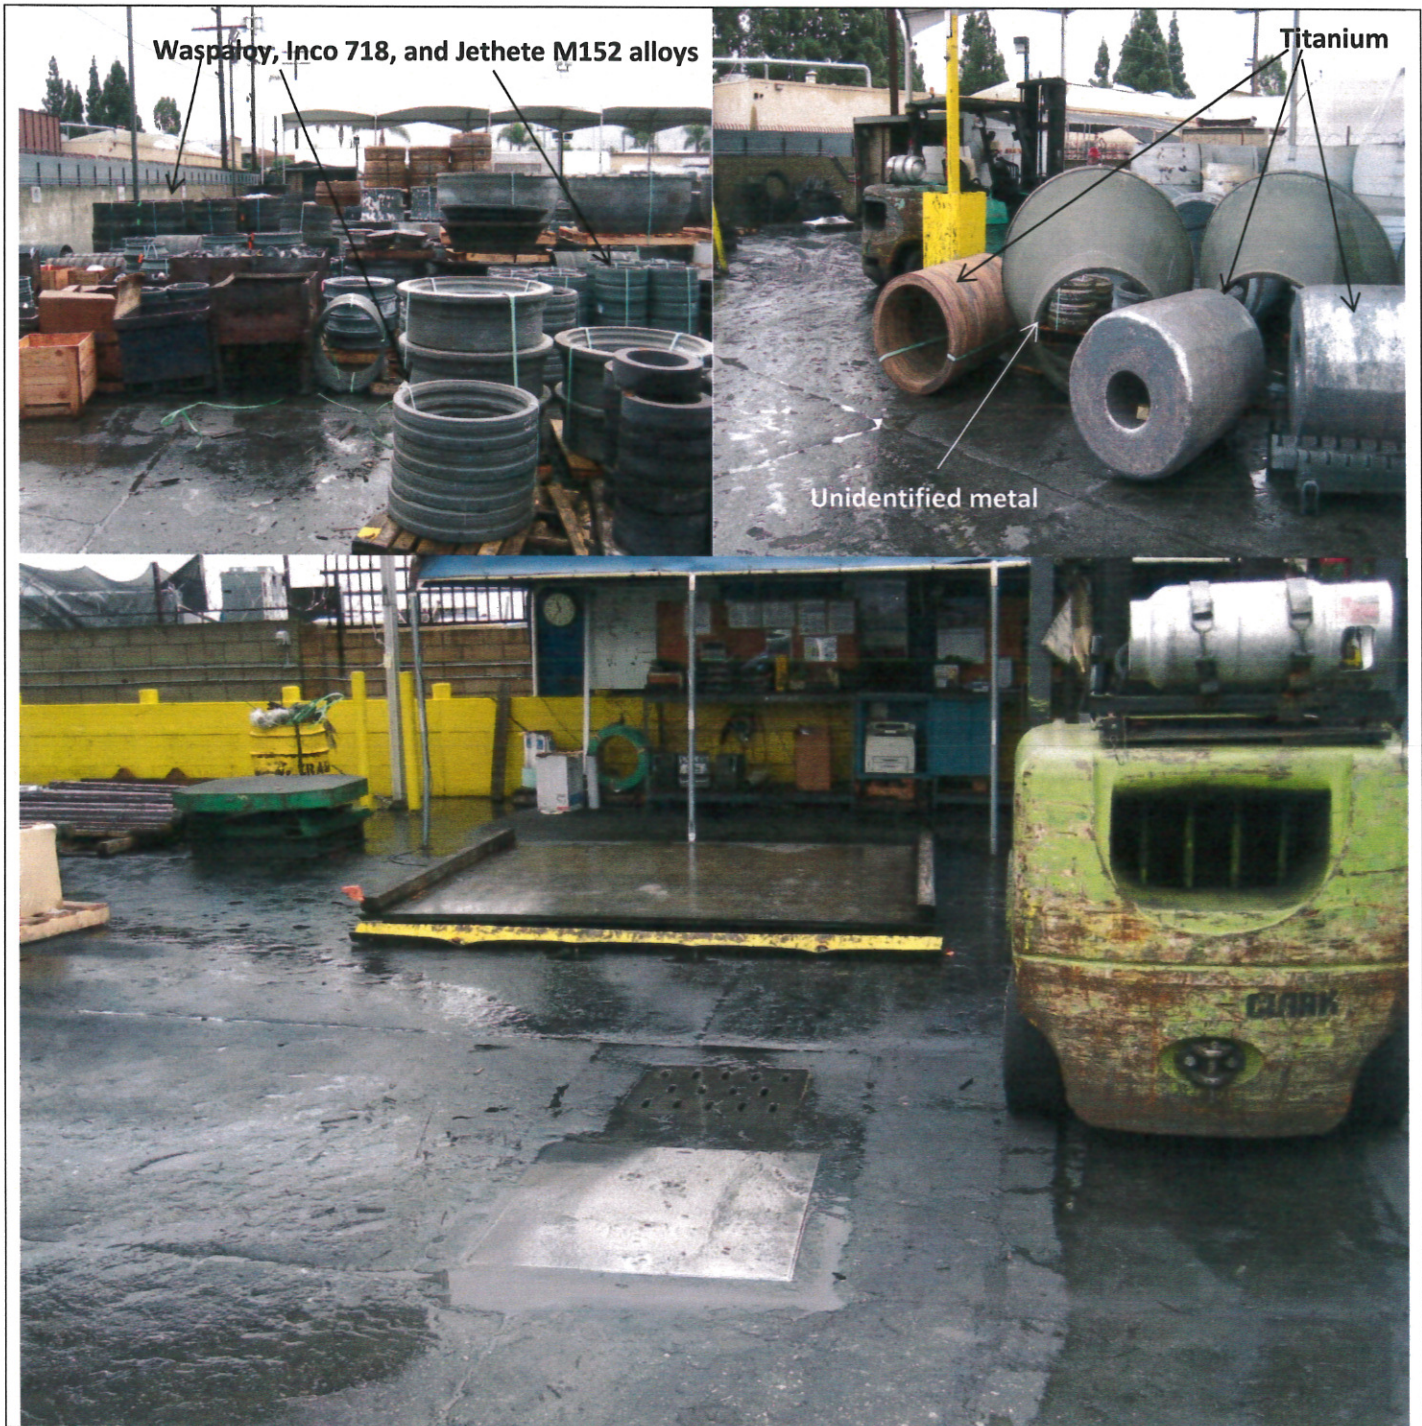
Photographs 3-5 –The photographs show Waspaloy, Inco 718, Jethete M152 alloys, and titanium part stored at the shipping and receiving yard without overhead coverage. Titanium parts and other unidentified metals were directly placed on the ground. In addition, the photographs show a drain that directly discharges into the street. At the time of the inspection, the drain was unprotected and discharging oily and dark storm water runoff offsite.

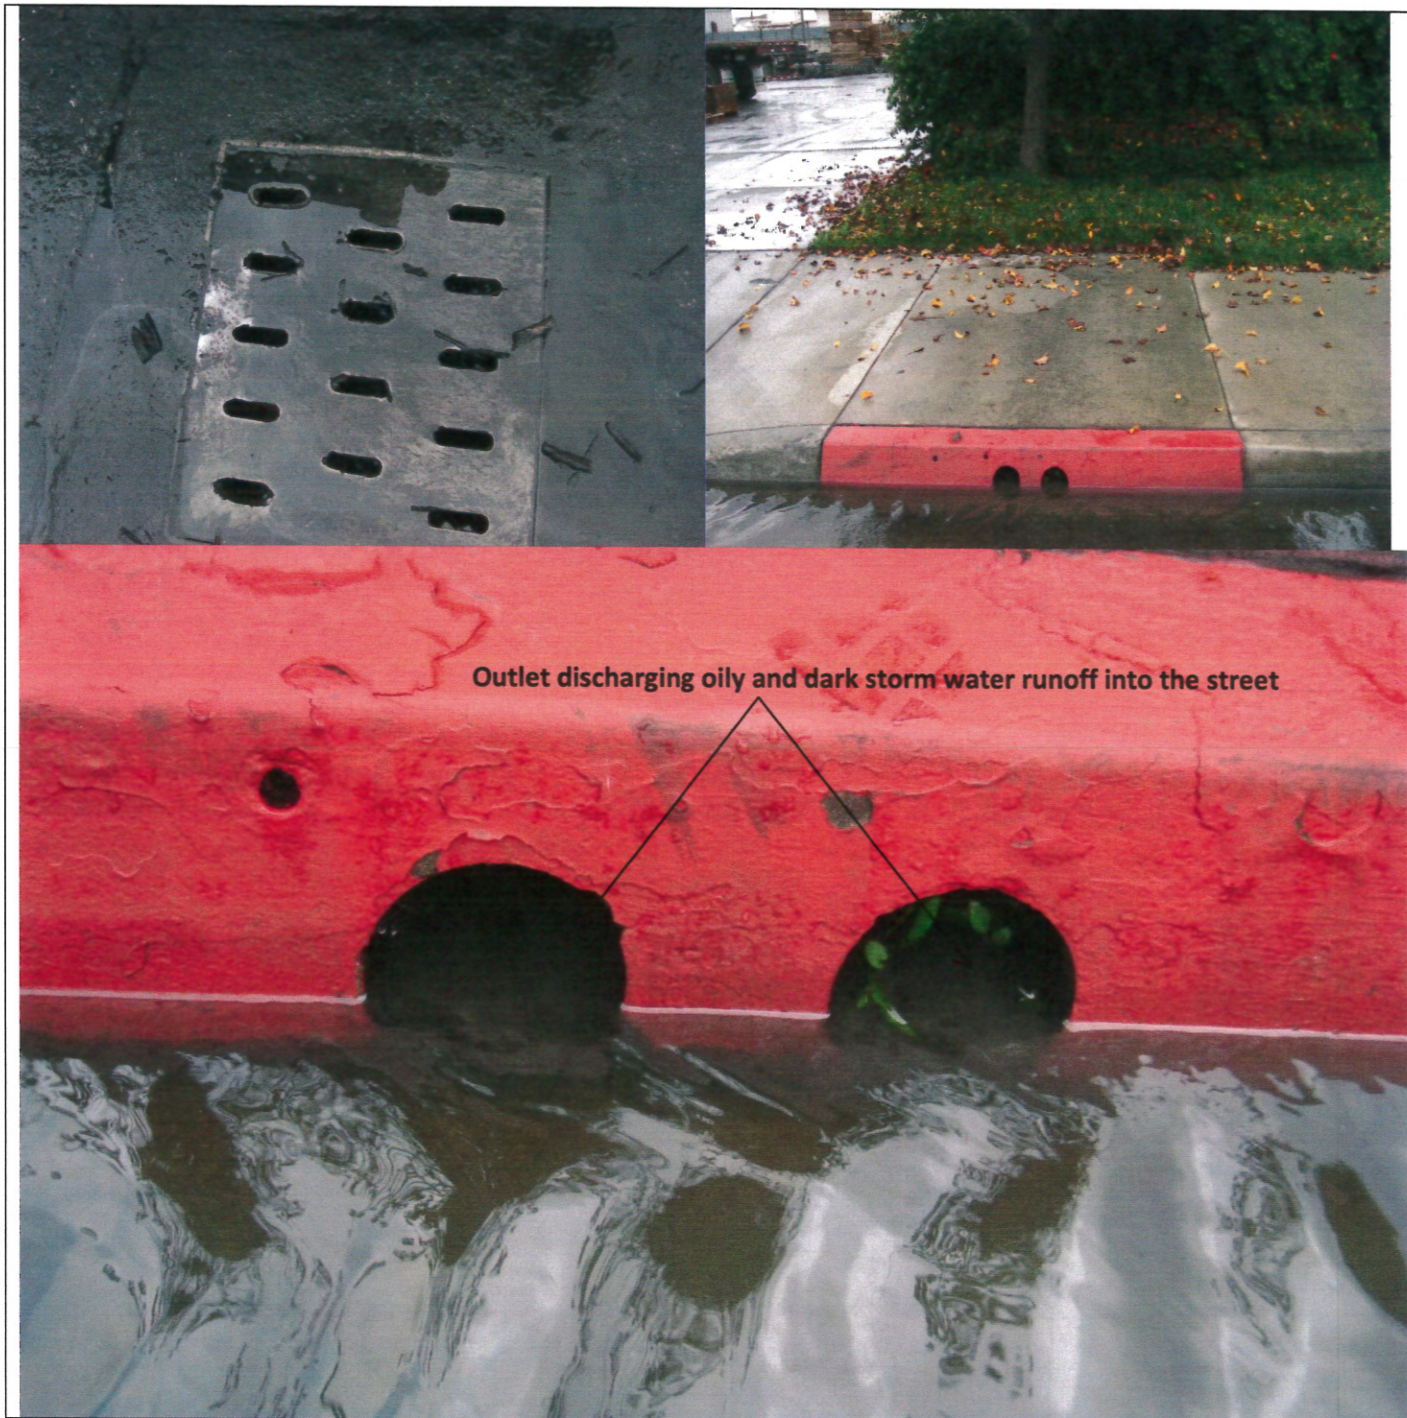
Photographs 6-8 –The photographs show the drain from previous photographs discharging offsite oily and dark storm water runoff.

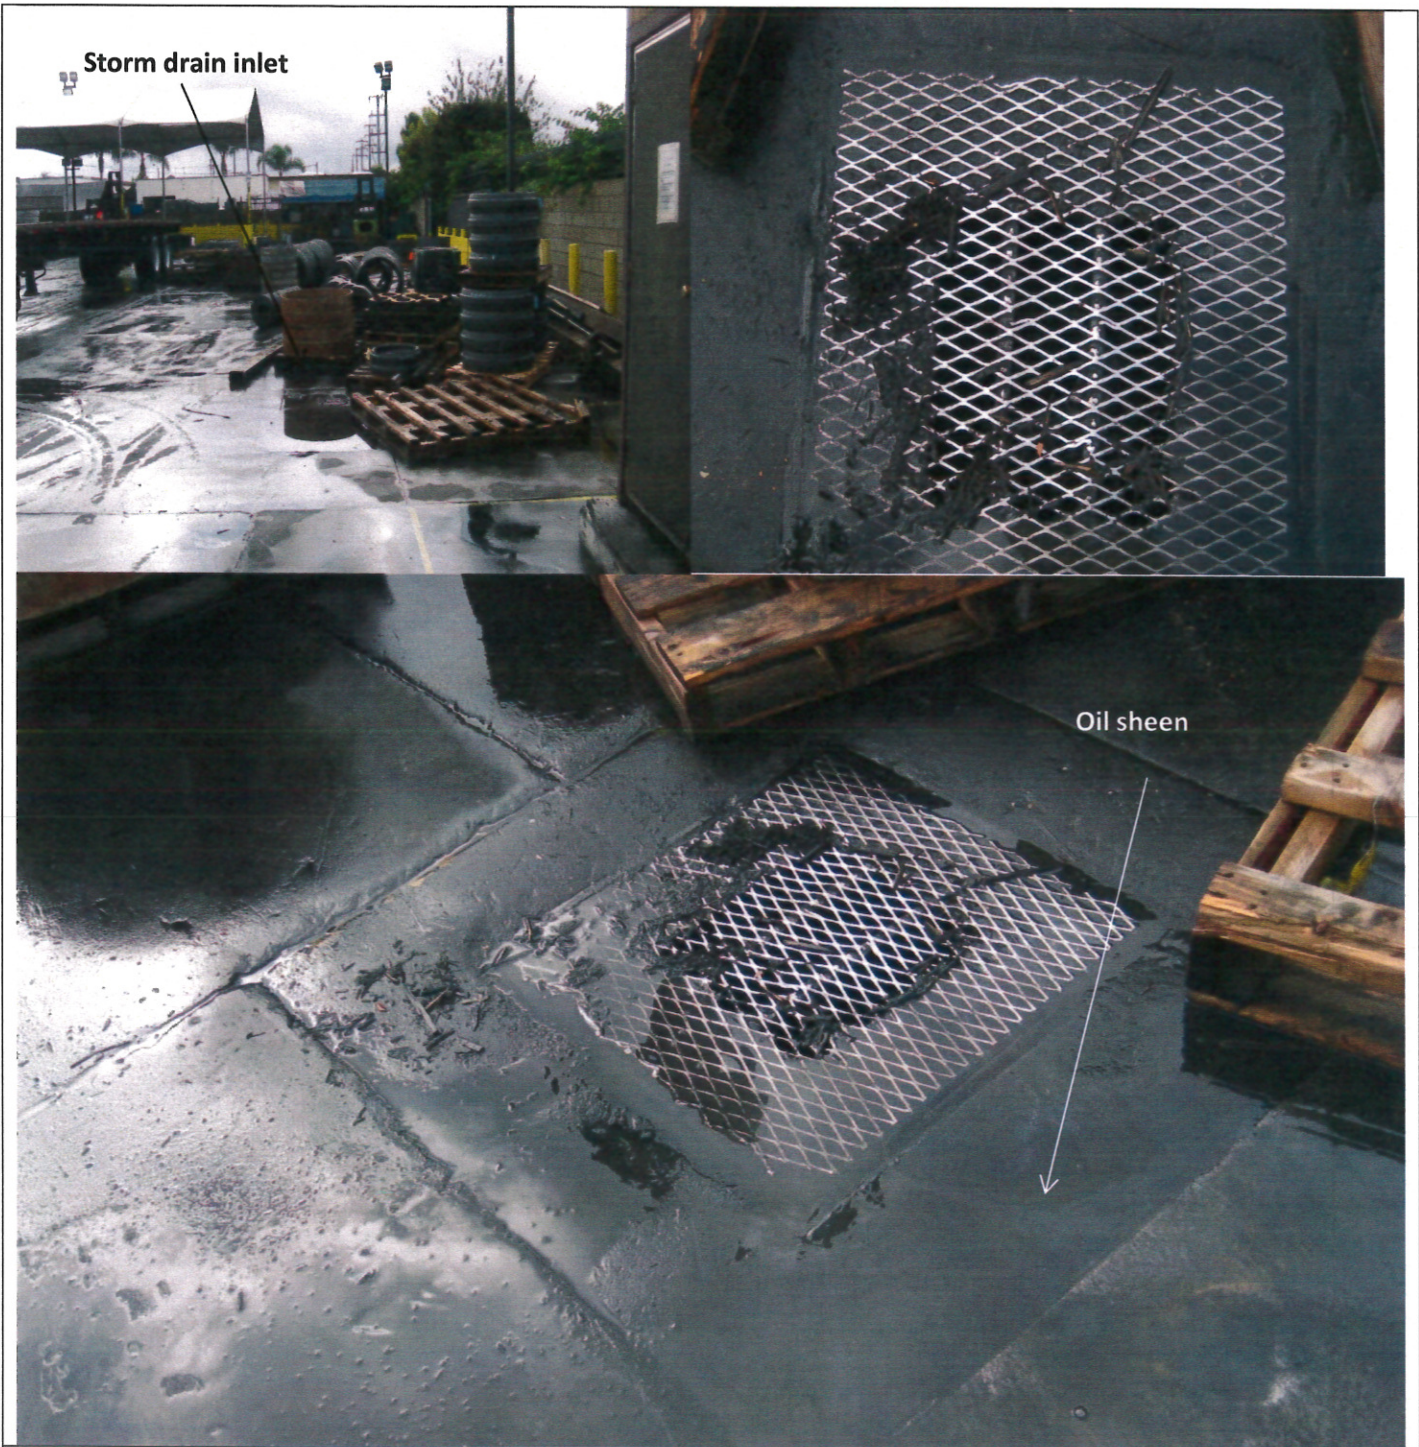
Photographs 9-11 –The photographs show the storm drain inlet from photographs 3 and 4. At the time of the inspection, it was raining and the storm drain was unprotected and discharging oily and dark storm water runoff offsite.

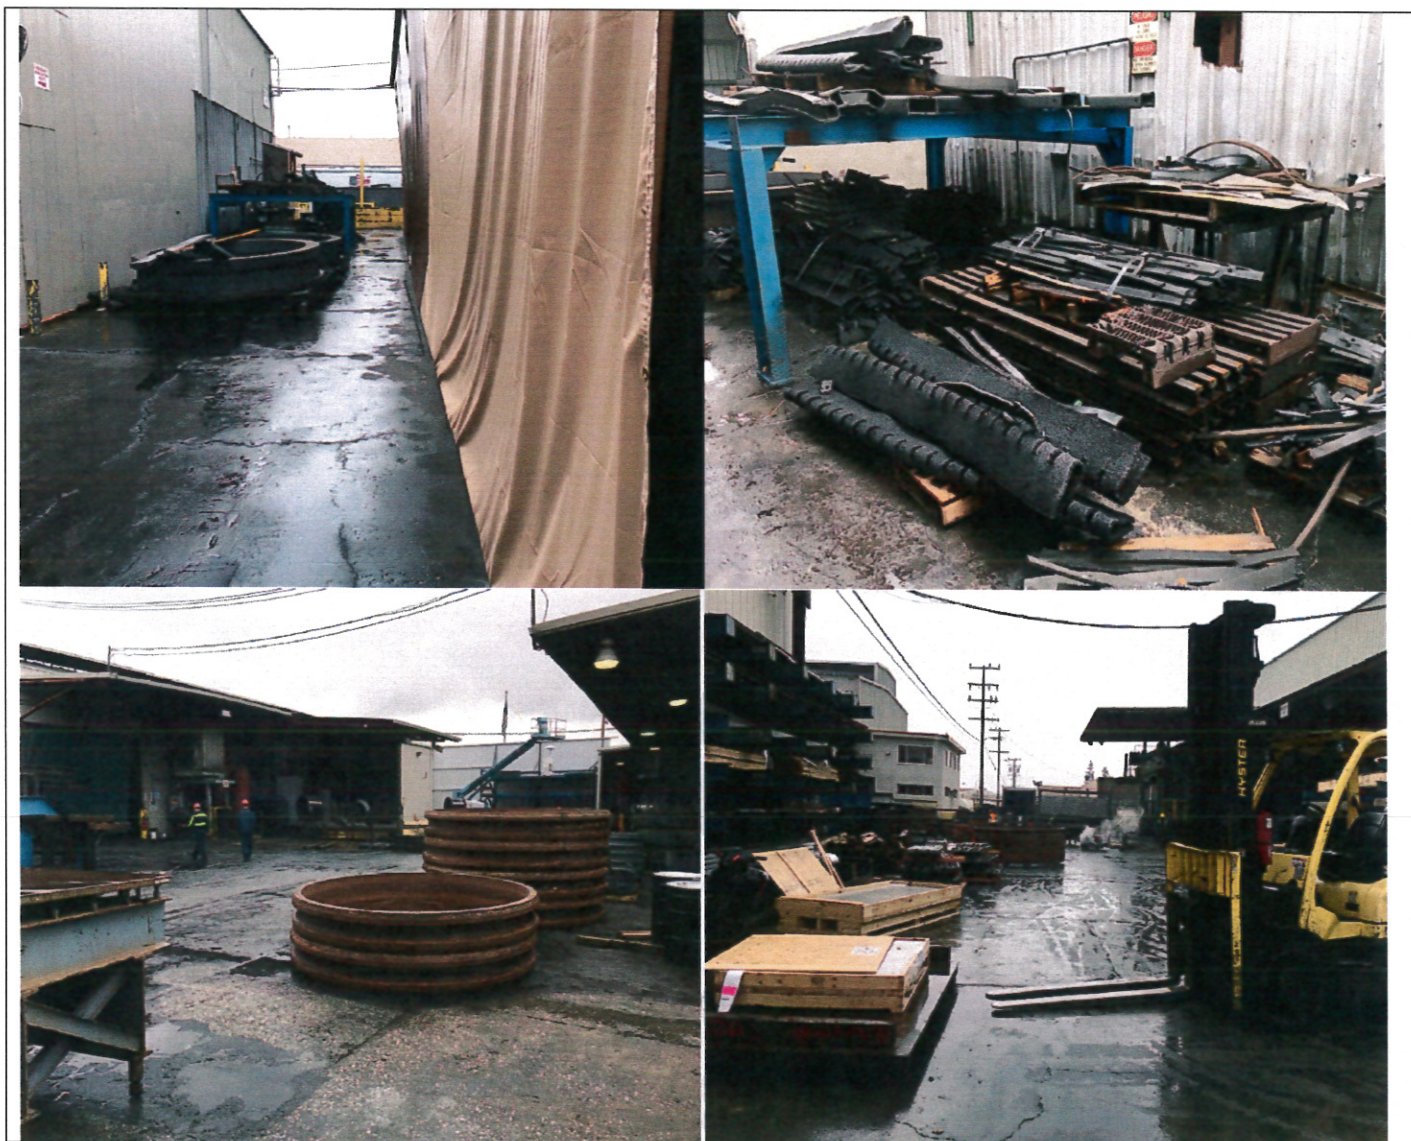
Photographs 11-15 –The photographs show scrap metal and other unknown metals stored outdoors without overhead coverage and some placed directly on the ground. At the time of the inspection, it was raining and all of the metal parts were in contact with storm water.
